**REMOVAL PROGRAM
AFTER ACTION REPORT
FOR THE
PARK STREET SITE
(b) (6)
BENNINGTON, BENNINGTON COUNTY, VERMONT
17 SEPTEMBER THROUGH 12 JULY 2013**

The following report, entitled *Removal Program After Action Report for the Park Street Site, Bennington, Bennington County, Vermont*, is a chronological summary of the response actions taken by the U.S. Environmental Protection Agency (EPA), Region I, Emergency Planning and Response Branch (EPRB). The report details the situation as it developed, actions taken, and resources committed.

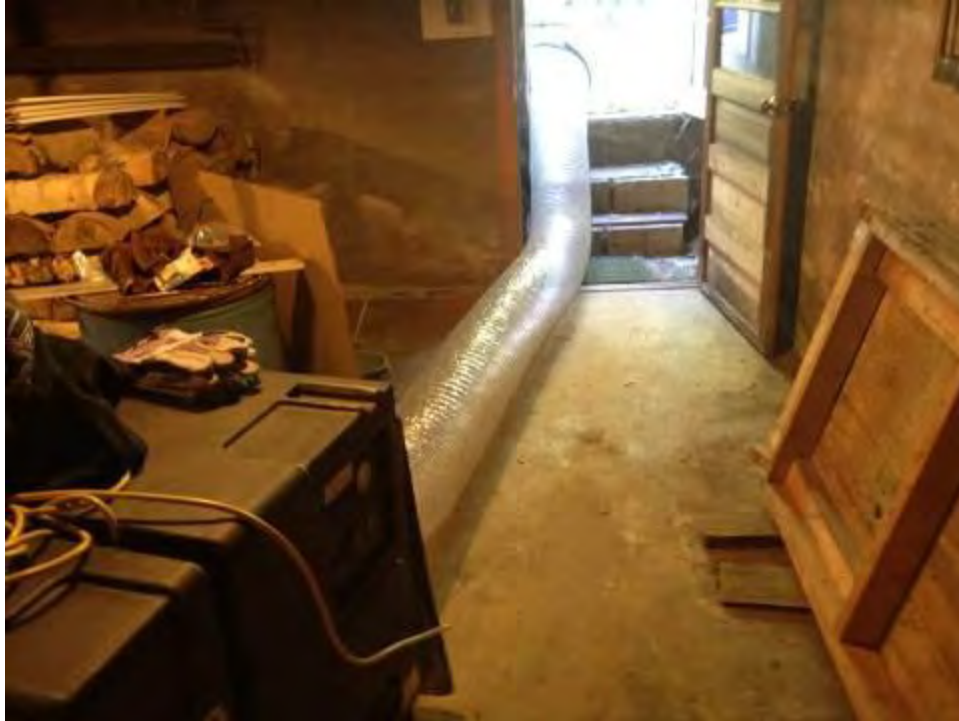
SCENE: View of the negative air system set up at (b) (6) during decontamination activities.

- Conducting air monitoring for particulates, volatile organic compounds (VOCs), and explosive atmosphere as specified in the HASP.
- Decontaminating the basement areas and the items within the basement of (b) (6) using a High Efficiency Particulate Air (HEPA) vacuum before wiping areas and items with cleaning products. The cleaning products used in the decontamination were Lestoil® and Pine Sol®.
- Replacing all the basement items to their original locations after the decontamination activities had been completed.

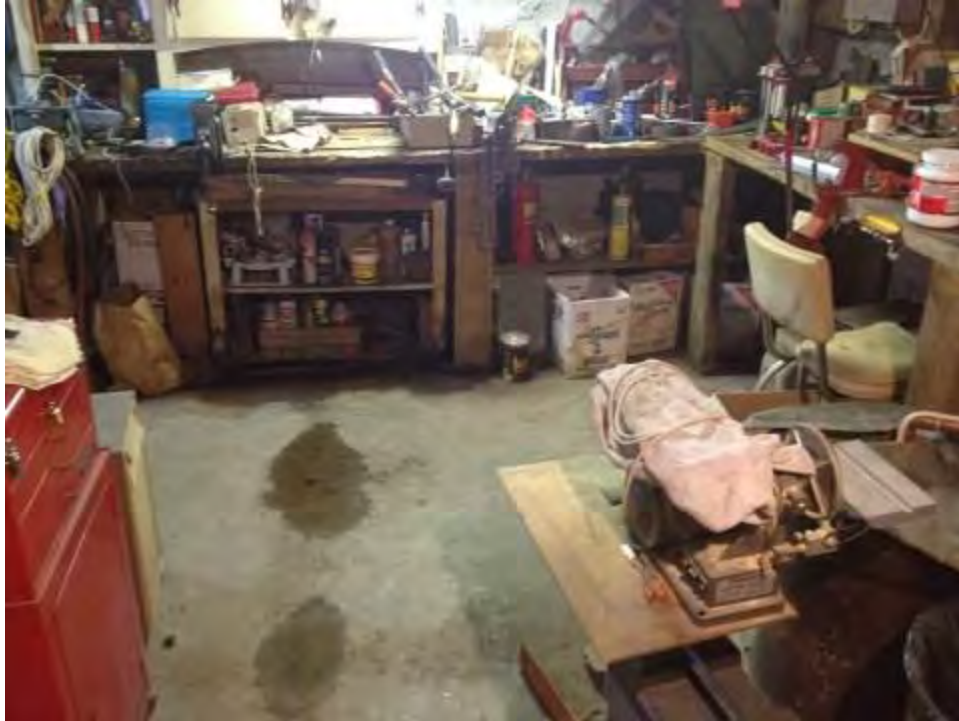
SCENE: View of the southeastern basement area at (b) (6) prior to decontamination. Water is visible on the floors.

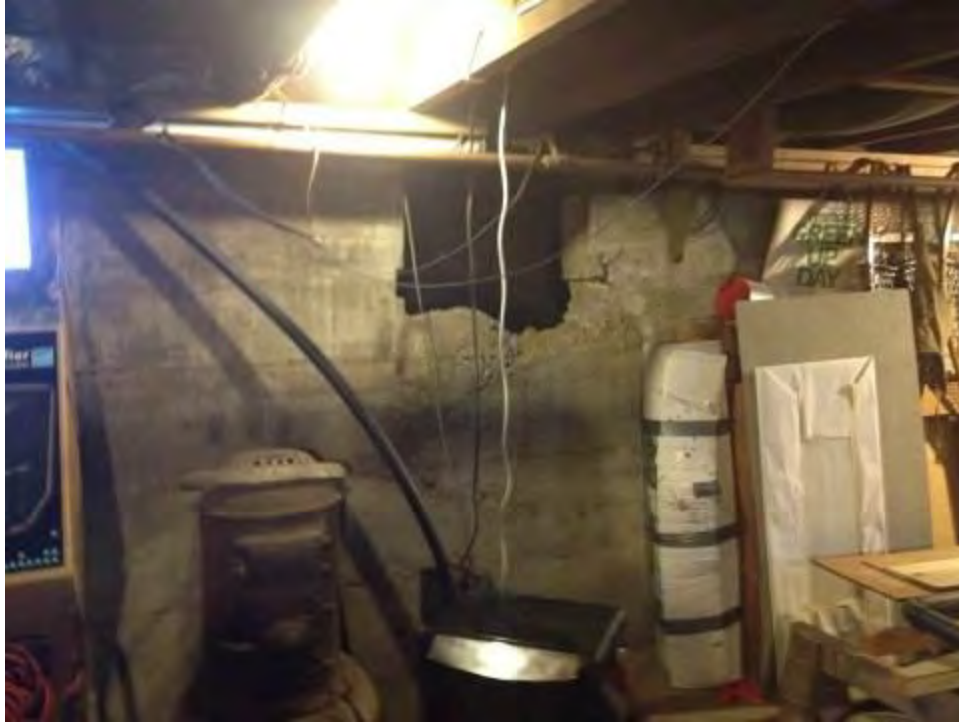
SCENE: View of a hole in the northern basement wall at (b) (6). The photograph was taken prior to decontamination.

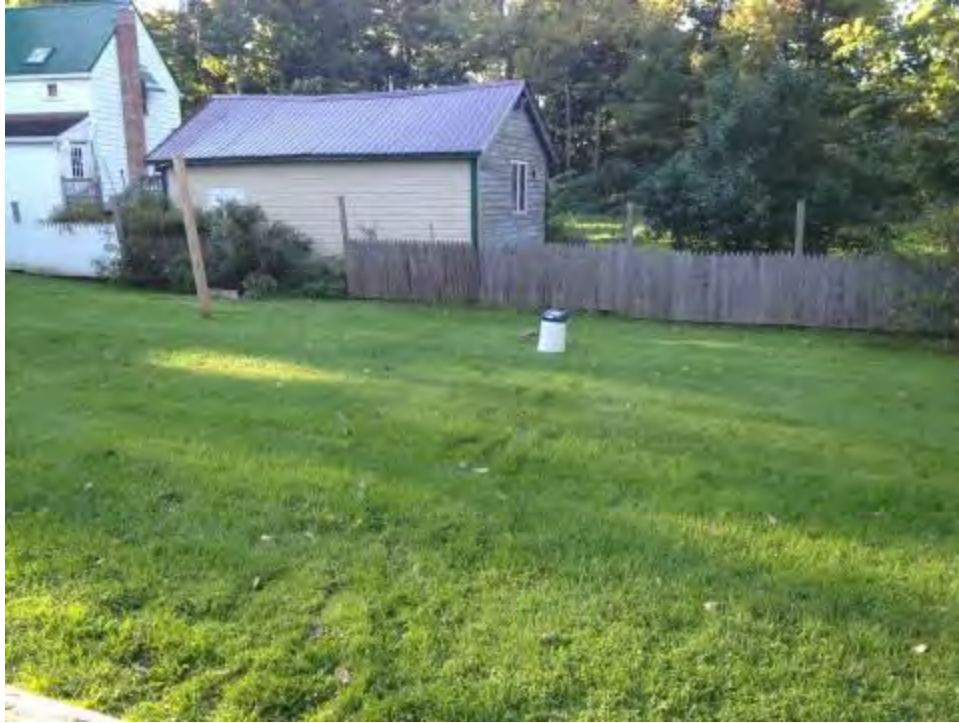
SCENE: View of the location of particulate air monitor No. 2 at (b) (6). Photograph taken facing south.

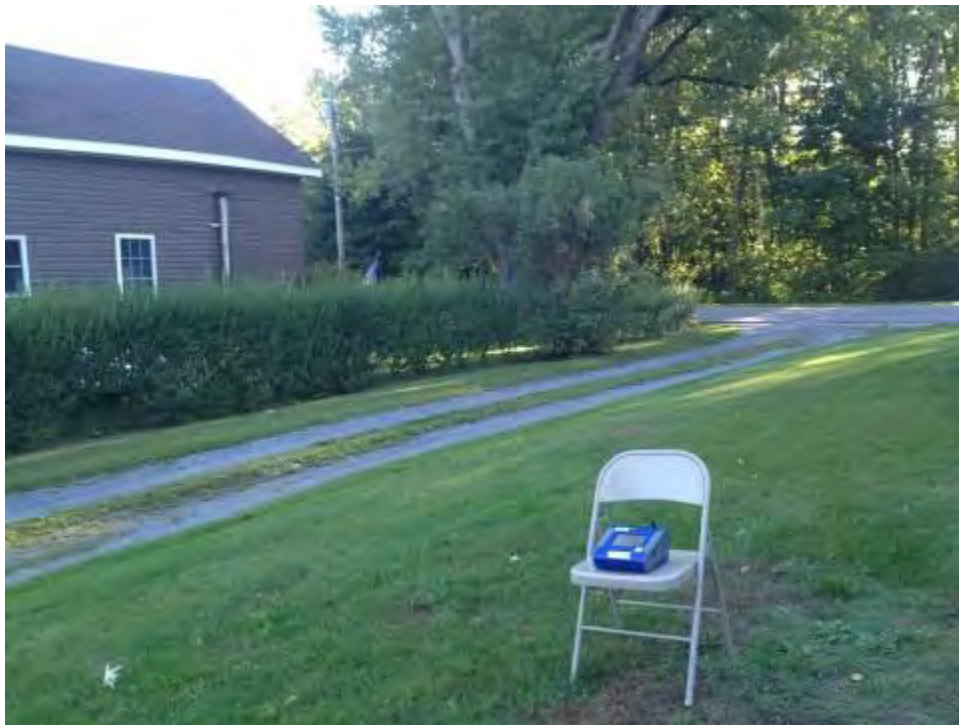
SCENE: View of the location of particulate air monitor No. 1 at (b) (6). Photograph taken facing northeast.

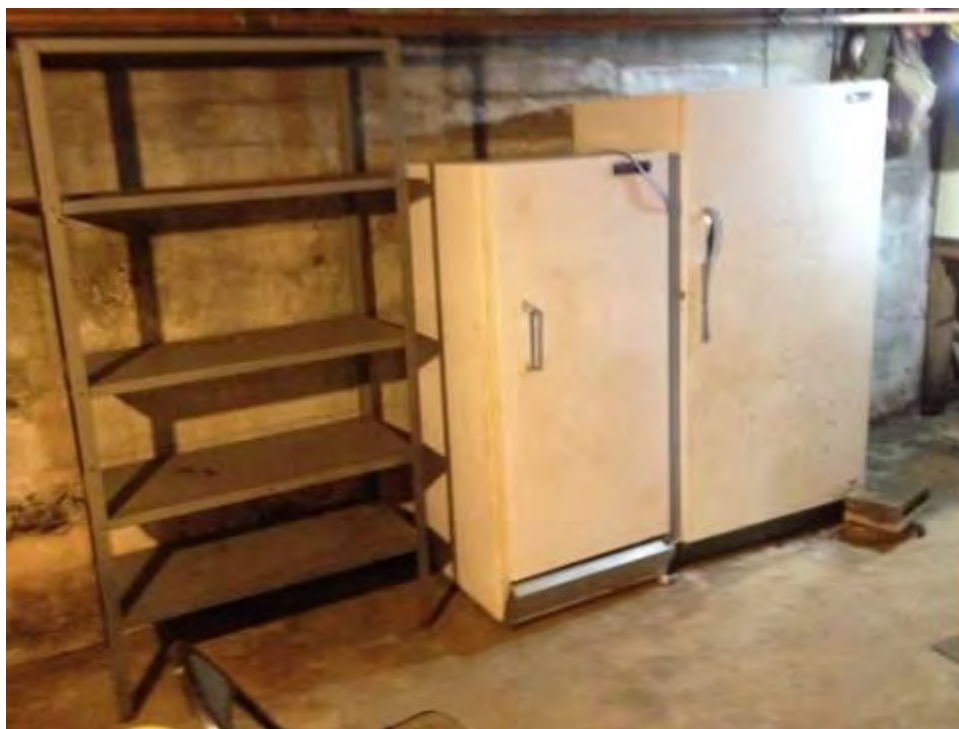
SCENE: View of wipe sample (WS) locations WS-06 and WS-07 collected from the freezer doors at (b) (6). The photograph was taken following decontamination.

SAMPLE LOCATION SAMPLE NUMBER SAMPLE DATE SAMPLE SURFACE	WS-06 R01-120917DB-0006 9/22/2012 FREEZER-01 (b) (6)	WS-07 R01-120917DB-0007 9/22/2012 FREEZER-02 (b) (6)	WS-08 R01-120917DB-0008 9/22/2012 FURNACE (b) (6)	WS-09 R01-120917DB-0009 9/22/2012 WASHING MACHINE (b) (6)
COMPOUND				
Aroclor-1016	ND	ND	ND	ND
Aroclor-1221	ND	ND	ND	ND
Aroclor-1232	ND	ND	ND	ND
Aroclor-1242	ND	ND	ND	ND
Aroclor-1248	ND	ND	ND	ND
Aroclor-1254	ND	ND	ND	ND
Aroclor-1260	ND	ND	ND	ND
Aroclor-1262	ND	ND	ND	ND
Aroclor-1268	ND	ND	ND	ND

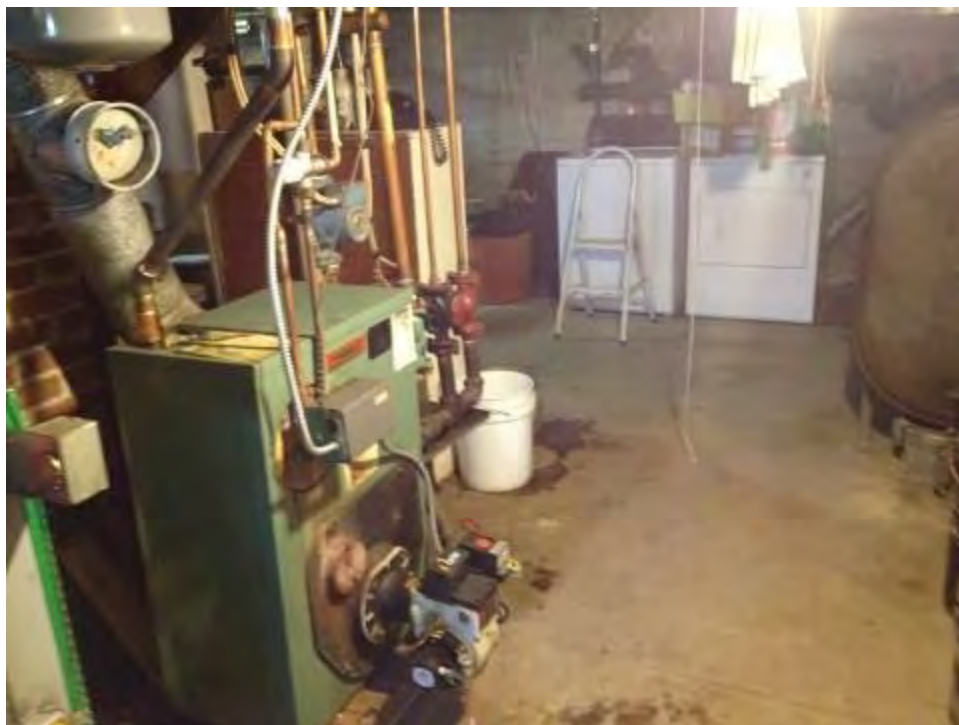
SCENE: View of wipe sample locations WS-08, WS-09, and WS-10 at (b) (6). The samples were collected from the furnace, washing machine, and the drying machine, respectively. The photograph was taken following decontamination.

SAMPLE LOCATION SAMPLE NUMBER SAMPLE DATE SAMPLE SURFACE	WS-10 R01-120917DB-0010 9/22/2012 DRYING MACHINE (b) (6)			
COMPOUND				
Aroclor-1016	ND			
Aroclor-1221	ND			
Aroclor-1232	ND			
Aroclor-1242	ND			
Aroclor-1248	ND			
Aroclor-1254	ND			
Aroclor-1260	ND			
Aroclor-1262	ND			
Aroclor-1268	ND

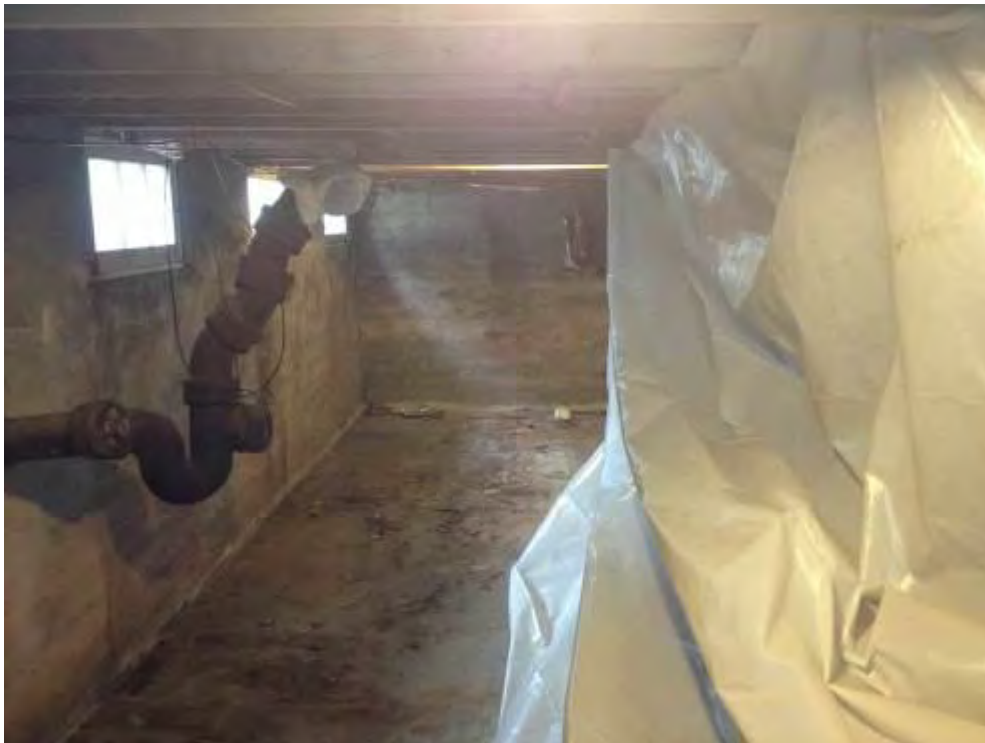
SCENE: View of polyethylene (poly) sheeting in the basement of (b) (6). Photograph taken facing west.

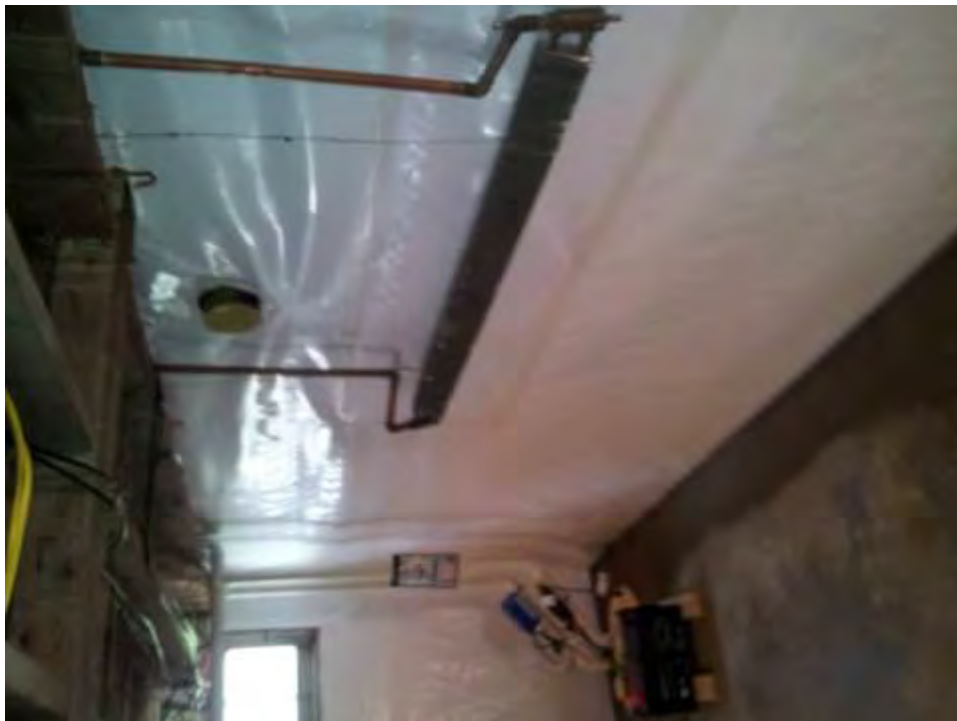
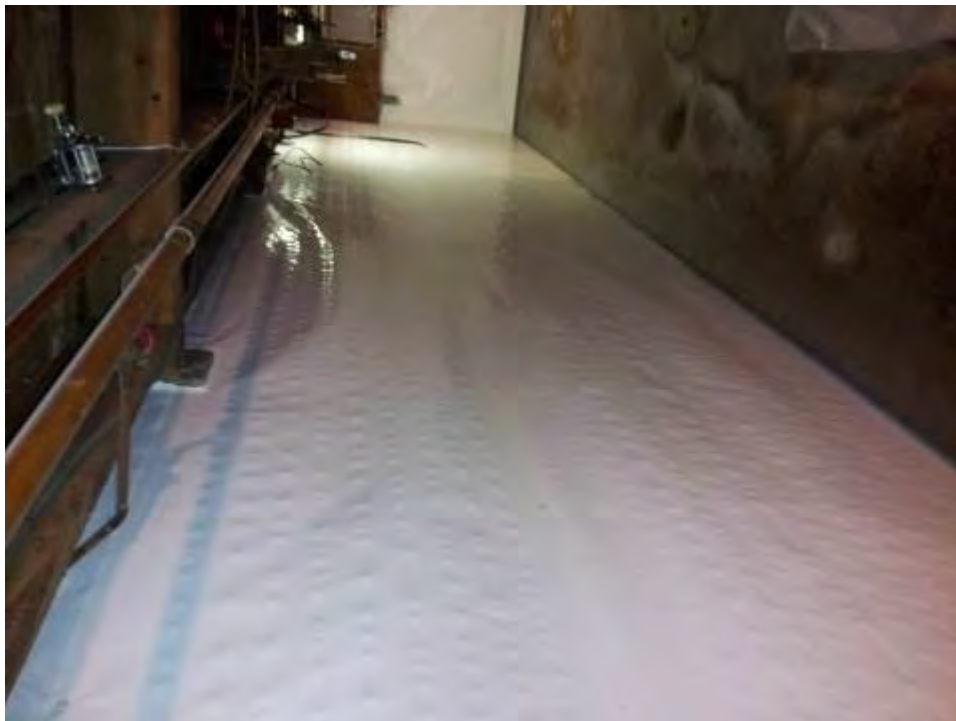
SCENE: View of the basement of (b) (6) after the installation of a poly liner and French Drain system. Photograph taken facing west.

SCENE: View of the basement of (b) (6) after the installation of a poly liner and French Drain system. Photograph taken facing southwest.

SCENE: View of the basement of (b) (6) after the installation of a poly liner and French Drain system. Photograph taken facing south.

- Mobilizing of crew and equipment.
- Reviewing and signing of the site HASP.
- Storing all items from the basement of (b) (6) in a portable storage unit for the duration basement waterproofing activities.
- Waterproofing the basement at (b) (6) to insure protection against PCB contamination via flooding.
- Installing a poly liner on the basement walls and installing an inner drain/French drain along the base of the walls at (b) (6).
- Replacing all the basement items back to their original locations after the basement waterproofing activities had been completed.

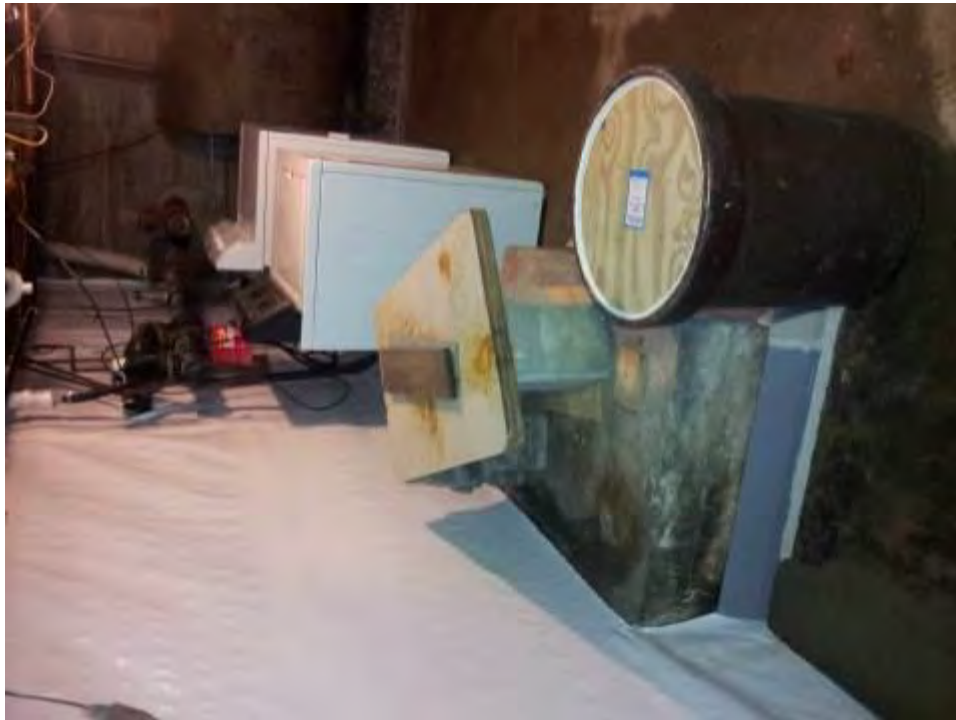
SCENE: View of the basement of (b) (6) after the installation of a poly liner and French Drain system. Also, visible in the rear of the photograph is the aboveground storage tank on a crushed gravel platform. Photograph taken facing west.

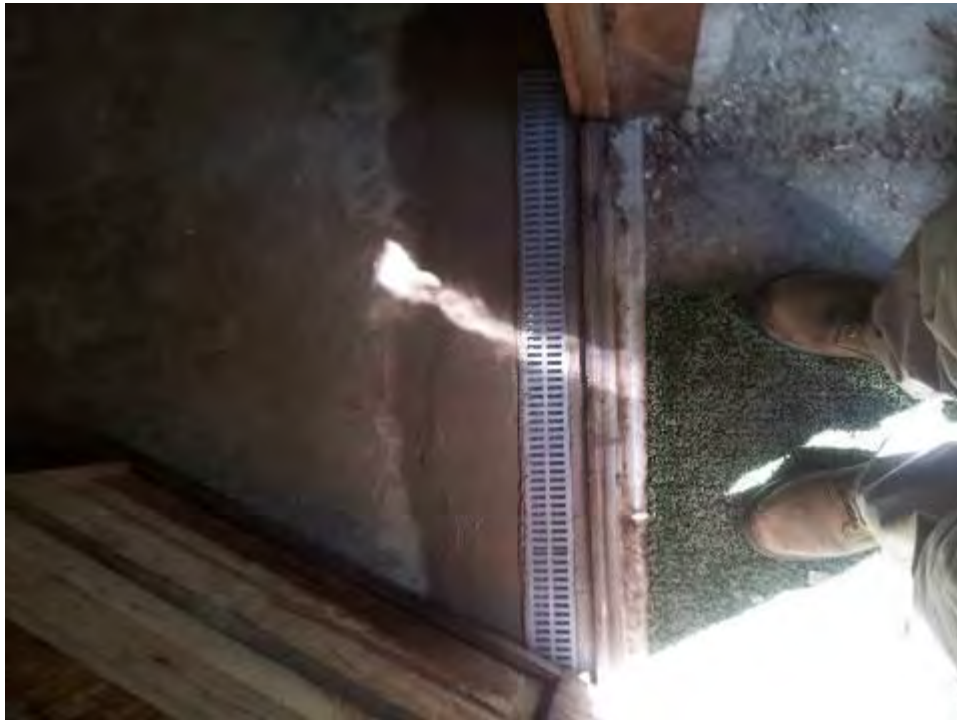
SCENE: View of a grate drain installed in the basement of (b) (6). The grate is located at the outside entryway to the basement. Photograph taken facing southeast.

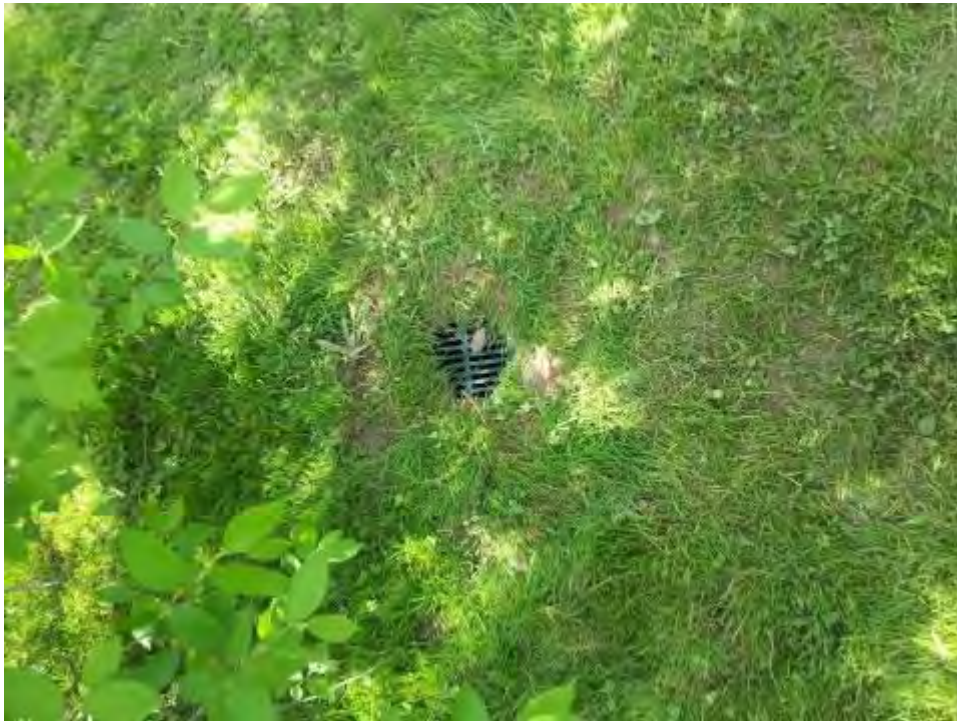
SCENE: View of a small catchbasin to the drainage pipe installed in the yard of (b) (6).

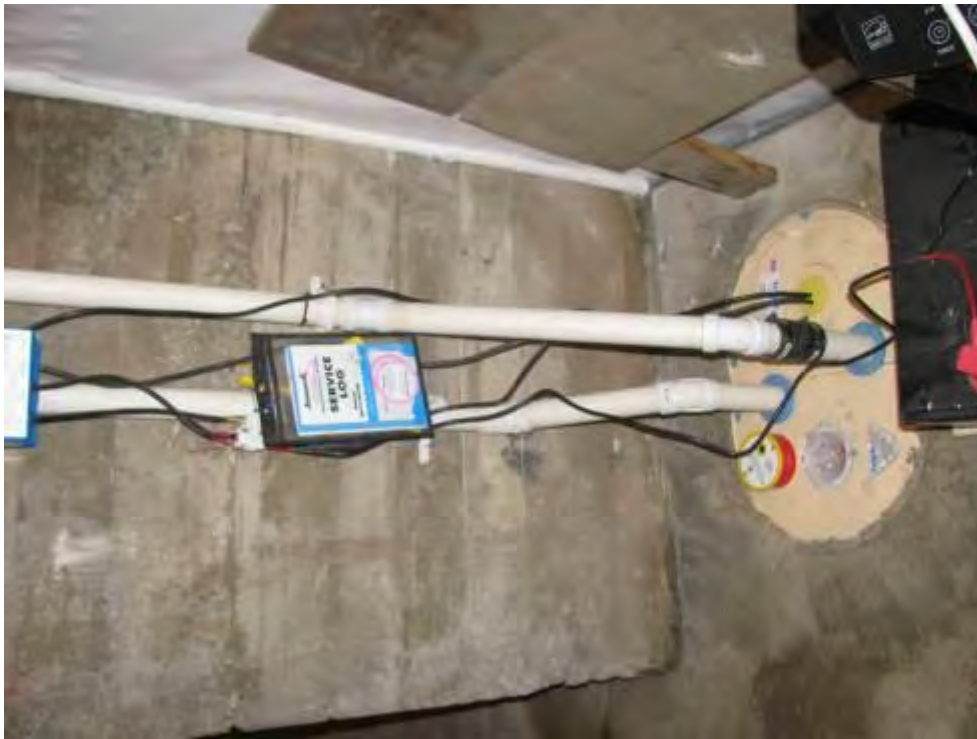
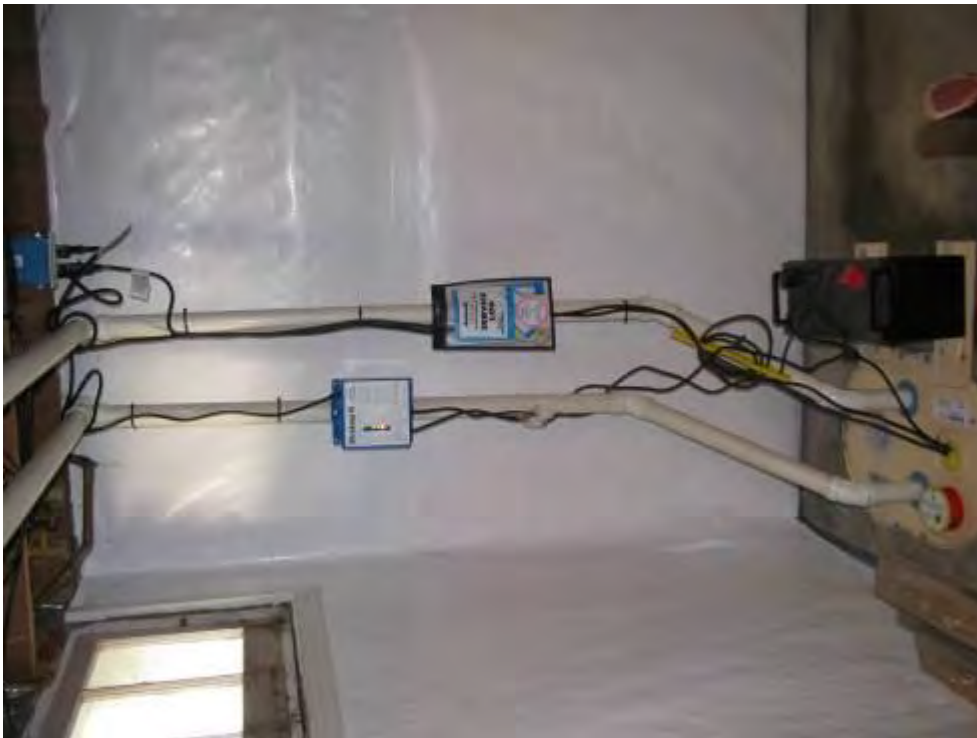
SCENE: View of the sump pump system installed in the basement of (b) (6). Photograph taken facing west.

SCENE View of the sump pump system installed in the basement of (b) (6). Photograph taken facing west.

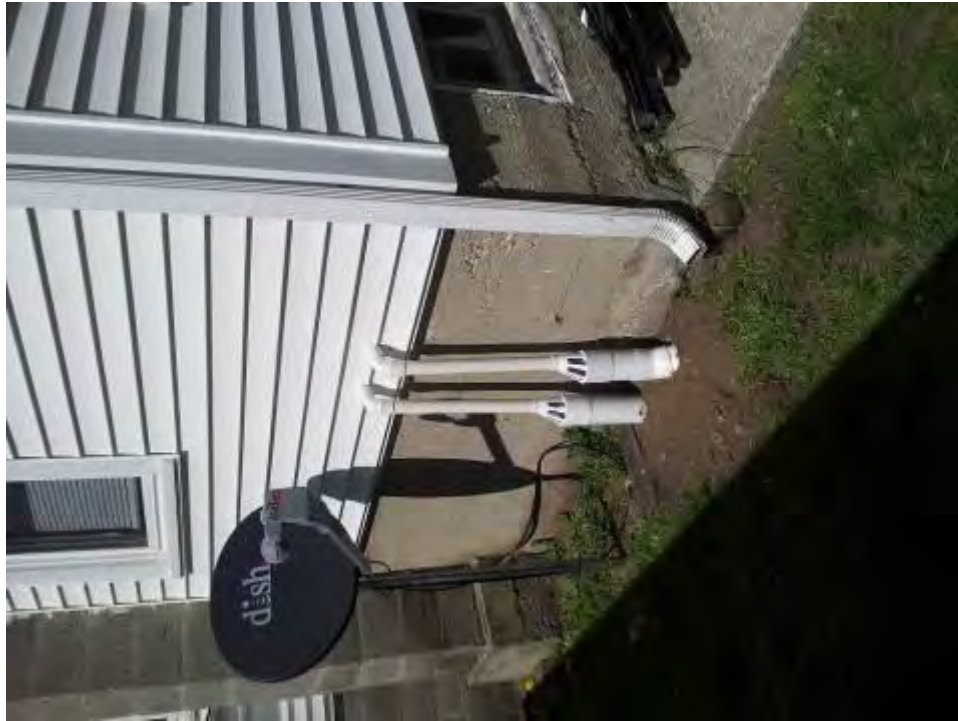
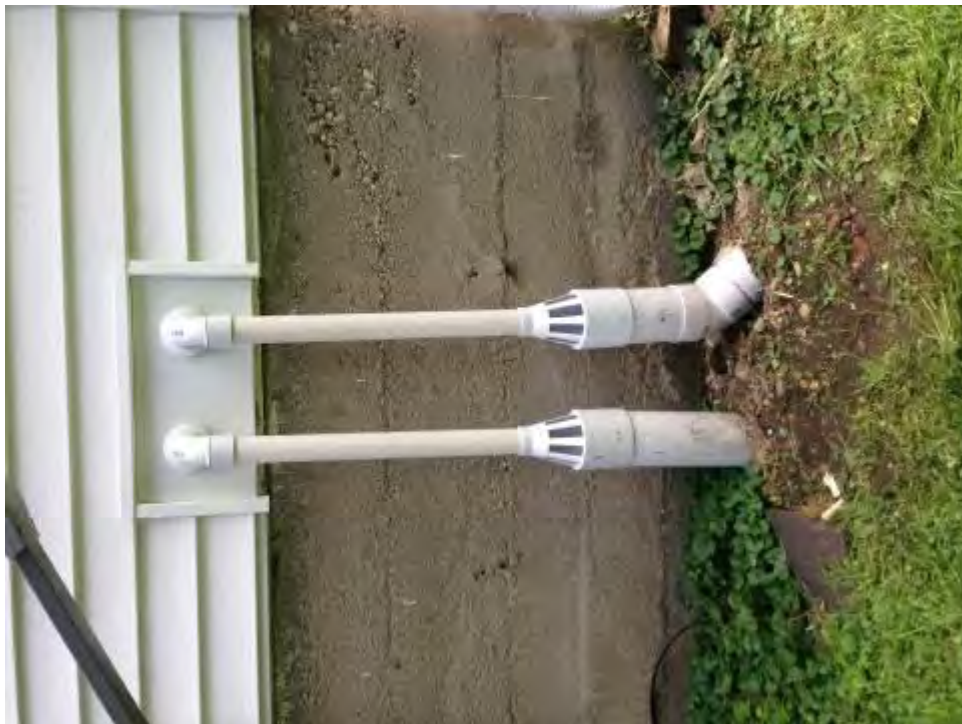
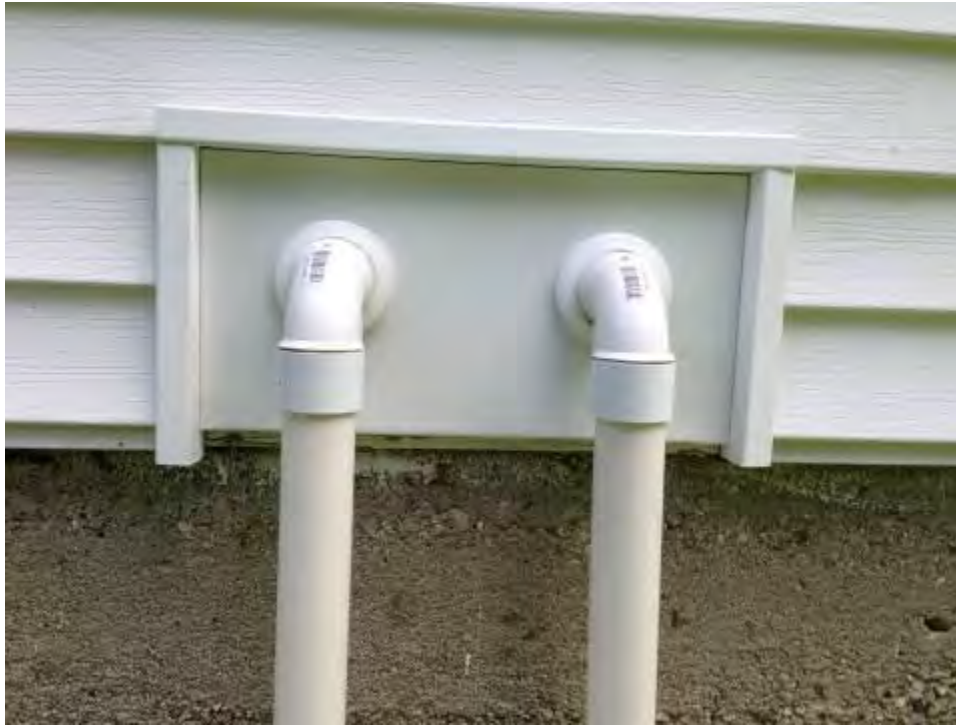
SCENE: View of effluent piping from the sump pump system from the (b) (6) basement. Photograph taken facing east.

SCENE: View of effluent piping from the sump pump system from the (b) (6) basement. Photograph taken facing south.

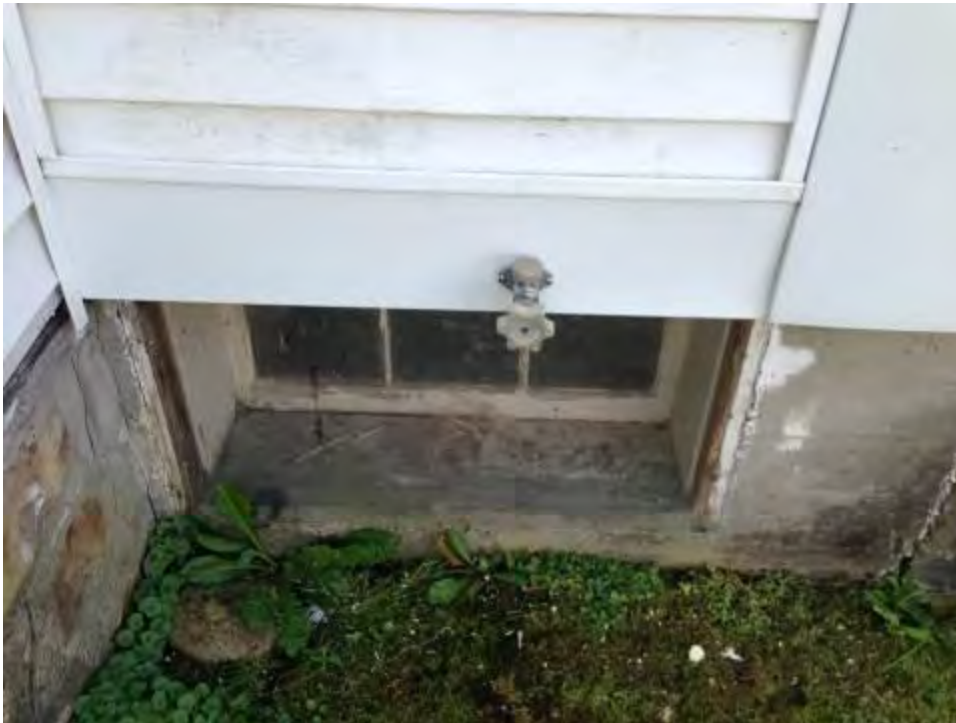
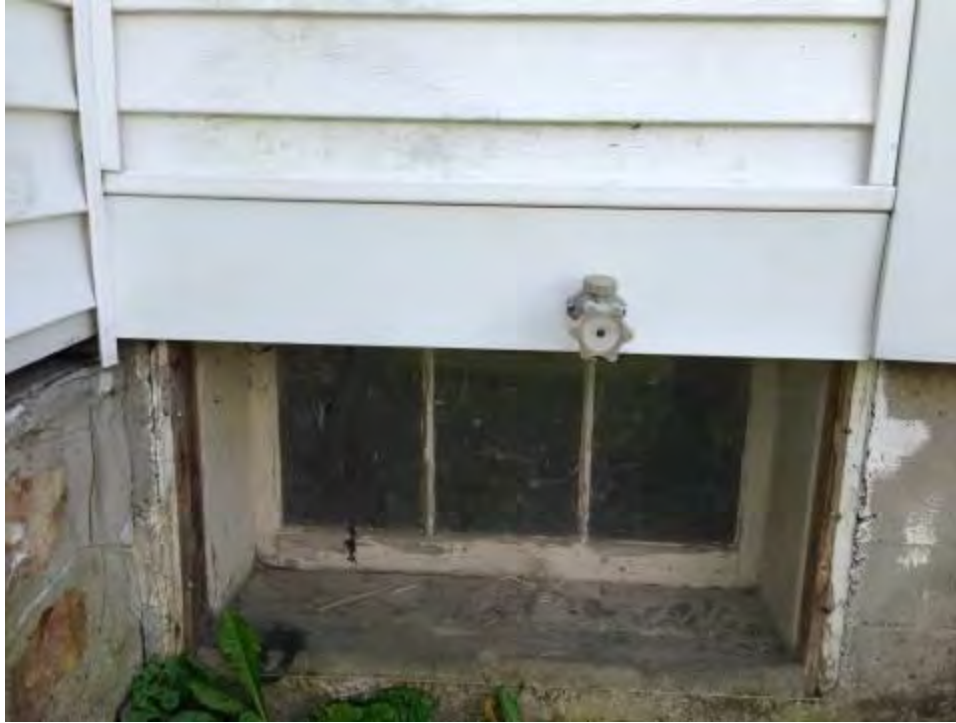
SCENE: View of repaired vinyl siding around a water spigot at (b) (6) Photograph taken facing south.

SCENE: View of repaired vinyl siding around a water spigot at (b) (6). Photograph taken facing south.

On 12 July 2013, ERRS mobilized to site to restore a section of the (b) (6) house siding.
